Inspection Report

Property Address:
123 Sample Street
TN

Chastain Home Inspection, LLC

Date: 8/3/2018	Time: 08:00 AM	Report ID: Chgastain2023
Property: 123 Sample Street TN	Customer:	Real Estate Professional:

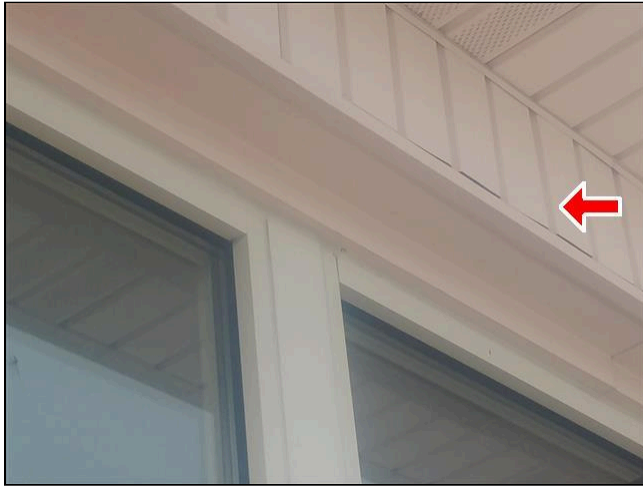
2.0 Item 1(Picture) Rear

Sections of the vinyl siding, located on the rear of home, are misaligned and possibly cut too short; creating gaps along the bottom of the siding. A contractor should evaluate and make the necessary repairs, else water can cause damage to the home's structure.

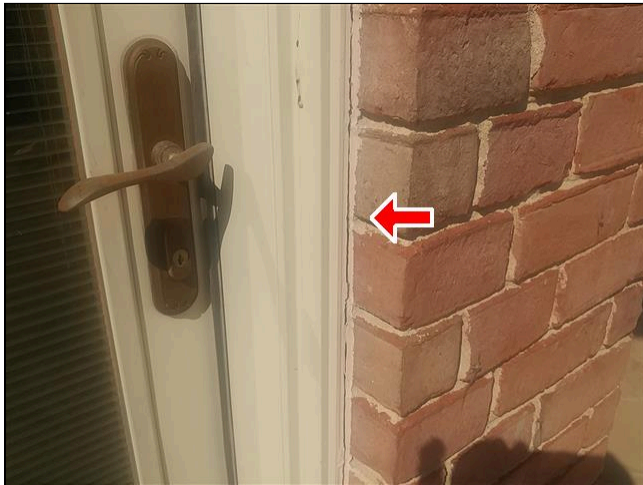
2.1 Item 1(Picture) Rear (leading to master bedroom)

(1) The caulking is cracked around the trim for the rear entry door, leading to master bedroom. A contractor should evaluate and make the necessary repairs, else water can cause damage to the home's structure.

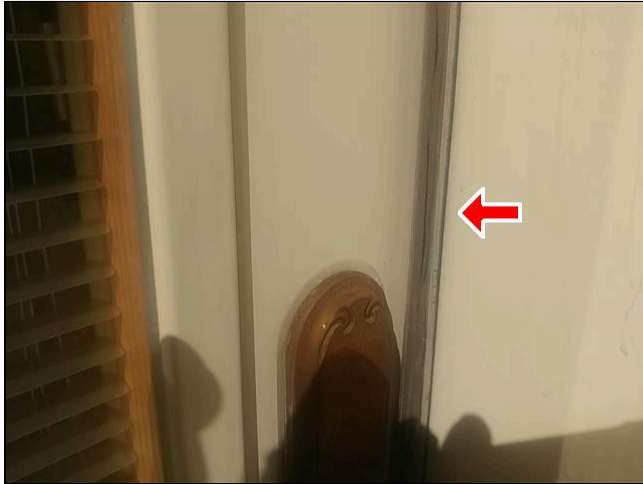
2.1 Item 2(Picture) Rear (leading to master bedroom)

(2) Replacing the damaged seal for the rear entry door (leading to master bedroom) should help with energy efficiency.

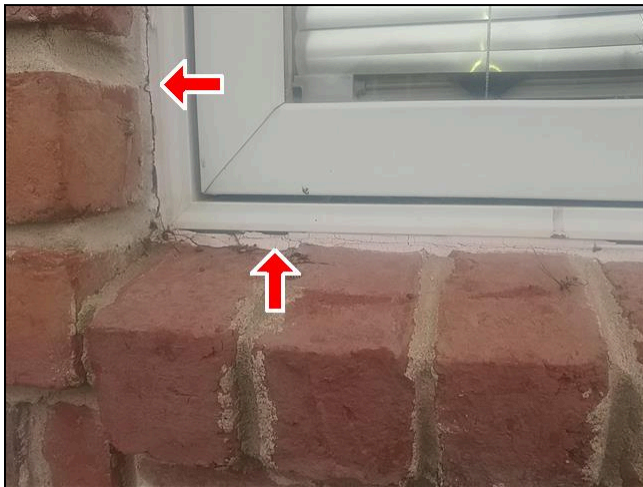
2.2 Item 1(Picture) Front

(1) The caulking is cracked around many of the windows. A contractor should evaluate and make the necessary repairs, else water can cause damage to the home's structure.

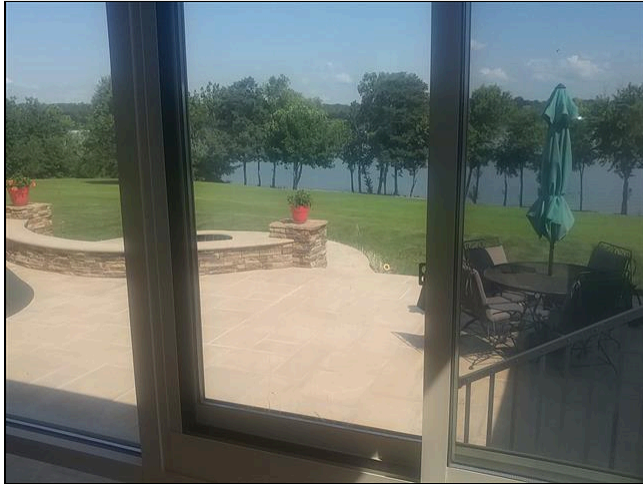
2.2 Item 2(Picture) Sunroom

(2) One of the sunroom windows has a cloudy appearance (moisture); indicating the seals have failed. Replacing the glass pane or the window should increase the efficiency of the home.

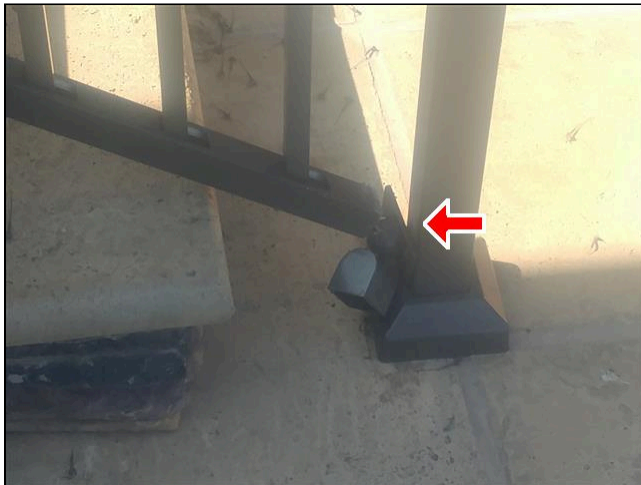
2.3 Item 1(Picture) Rear

Safety issue - The railing for the steps that lead to the rear entry is loose. A contractor should evaluate and make the necessary repairs, reducing the risk of a fall.

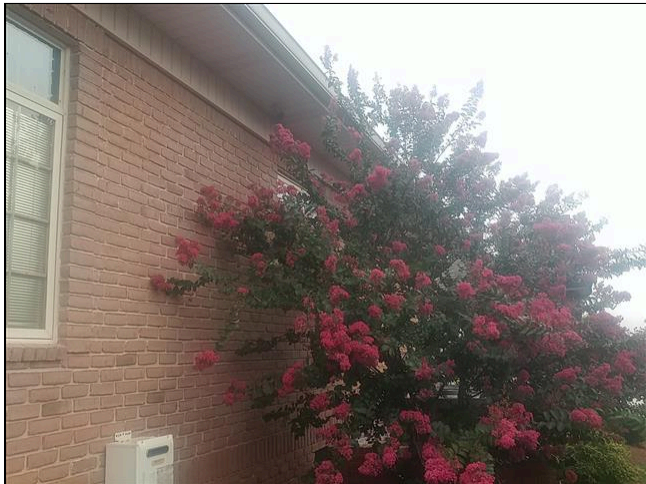
2.4 Item 1(Picture) Right side (facing front)

(1) Shrubs / vegetation are in contact with the home, which can cause the exterior of home to mold / mildew and possibly deteriorate. The vegetation should be trimmed to at least 10 inches away from the home.

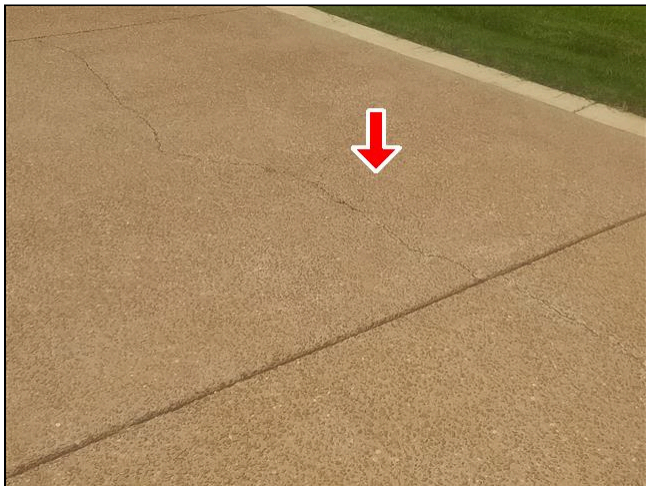
2.4 Item 3(Picture) Driveway

(2) Repairing the crack in the driveway will help to extend the life of the concrete and improve the appearance of the home.

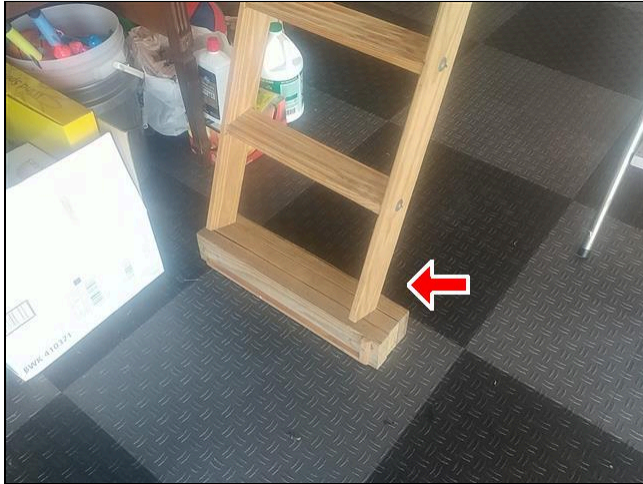
4.3 Item 1(Picture) Garage

Safety issue - The attic stairs are too short and will not reach the floor, without using a block of wood to support the ladder. A contractor should evaluate and make the necessary repairs, reducing the risk of a fall.

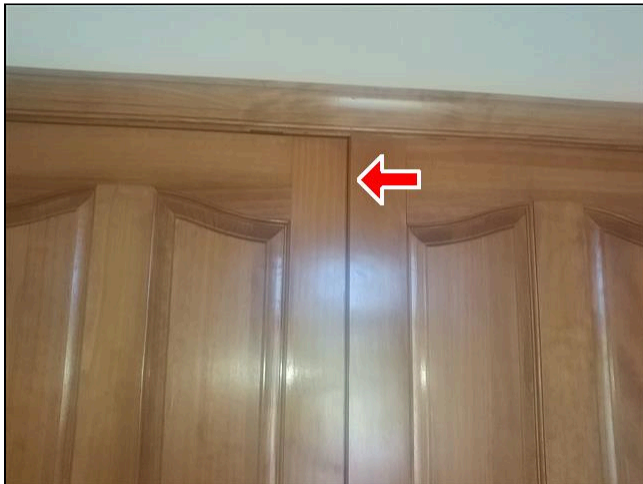
4.5 Item 1(Picture) Front guest bedroom

(1) The front guest bedroom closet doors are making contact with each other, causing the doors to be difficult to open or close. Adjusting the door hardware may correct this issue, else a contractor should evaluate and make the necessary repairs.

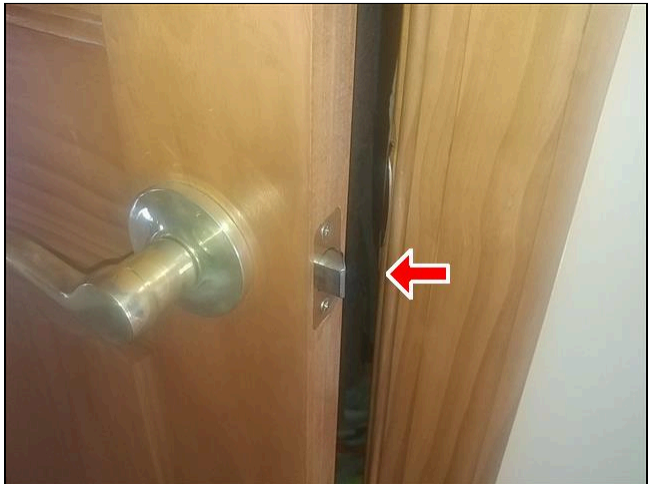
4.5 Item 2(Picture) Master bedroom closet

(2) The master bedroom closet door will not latch. Adjusting the door hardware may correct this issue, else a contractor should evaluate and make the necessary repairs.

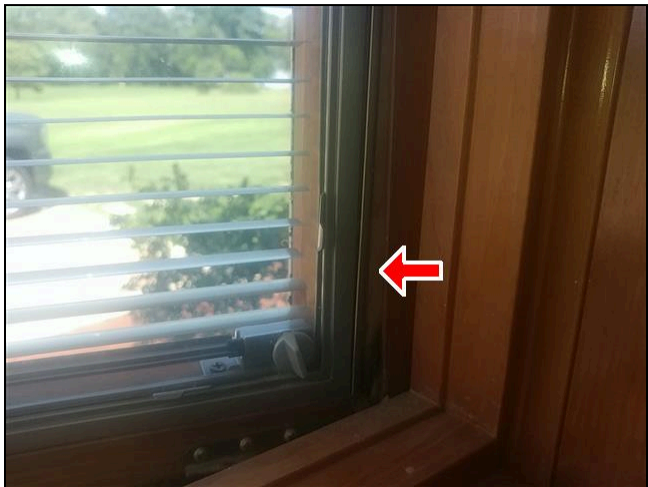
4.6 Item 1(Picture) Front guest bedroom

(1) The trim is separating on the front guest bedroom window, preventing the window from completely opening. A contractor should evaluate and make the necessary repairs.

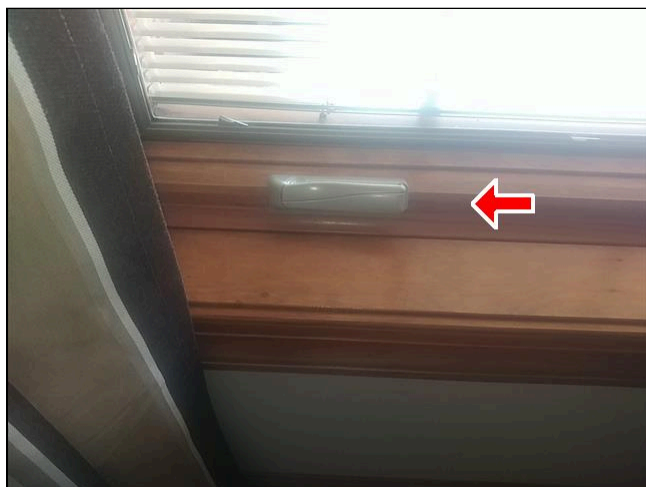
4.6 Item 2(Picture) Rear guest bedroom

(2) The rear guest bedroom window will not open. In addition, hardware on some of the windows appears to be different colors, indicating some windows may have been replaced. A contractor should evaluate and make the necessary repairs.

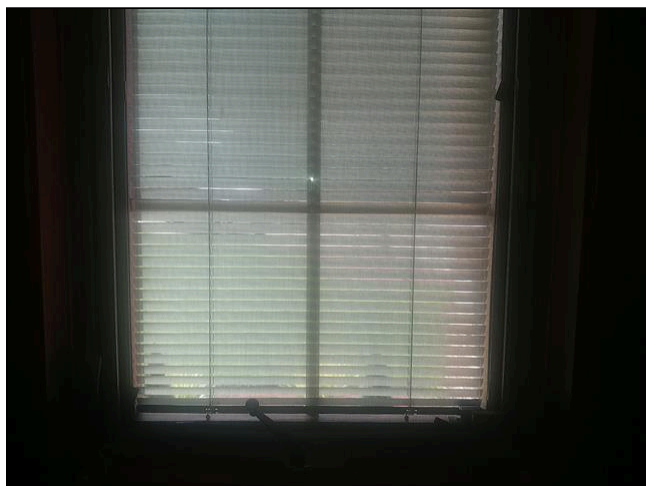
4.6 Item 3(Picture) Master bathroom

(3) The mini blinds in master bathroom toilet area will not open or close. A contractor should evaluate and make the necessary repairs.

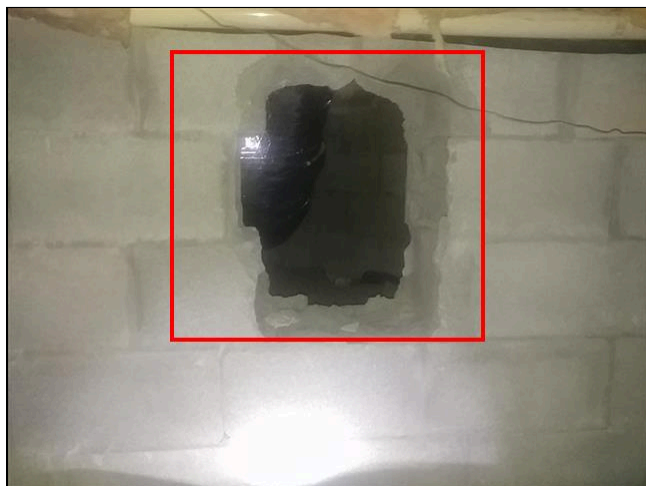
5.1 Item 1(Picture) Crawlspace

(1) A section of the foundation wall has been removed. The hole is approximately 16 by 20 inches. A contractor should evaluate and make the necessary repairs.

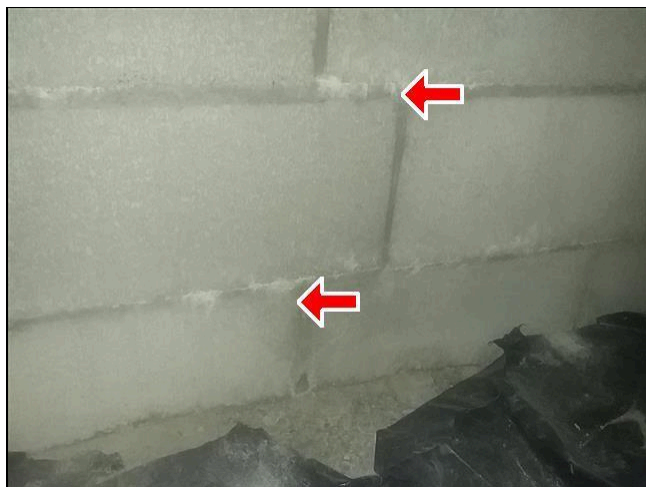
5.1 Item 2(Picture) Crawlspace

(2) Efflorescence is present on some of the front masonry blocks (foundation wall). Efflorescence is defined as: "the changing of certain crystalline compounds to a whitish powder or powdery crust through loss of their water of crystallization". Two conditions must be present to create efflorescence:

A contractor should evaluate and make the necessary repairs, else moisture can cause mold and structural damage.

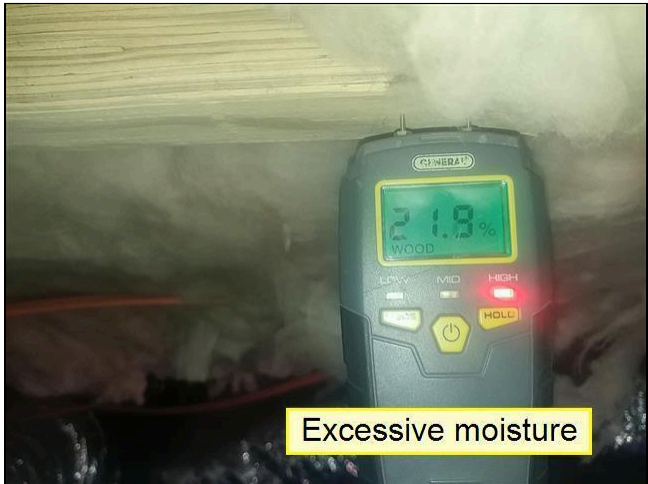
5.3 Item 1(Picture) Crawlspace

(1) The moisture level in the floor joists (viewed from crawlspace) was 21.9%, significantly above acceptable

levels. High moisture content promotes fungi growth and decay. A crawlspace specialist should evaluate and make the necessary repairs.

Excessive moisture

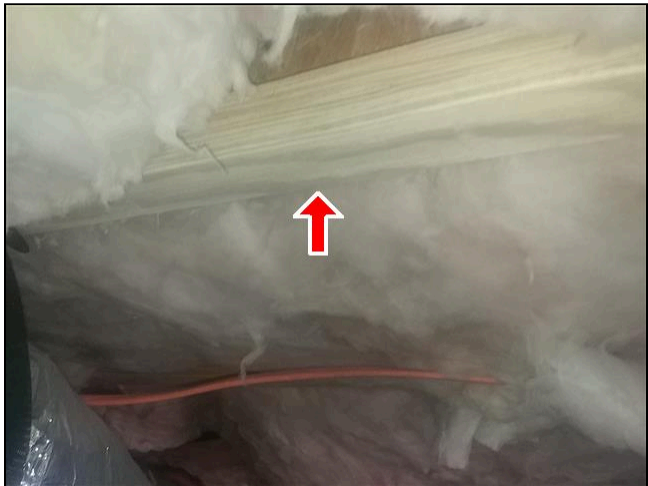
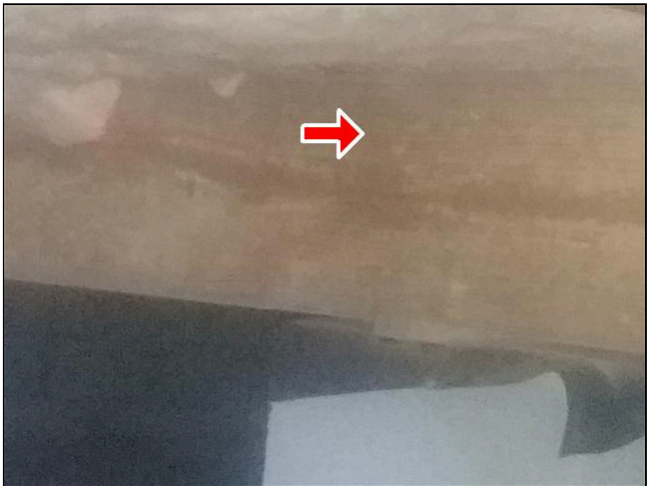
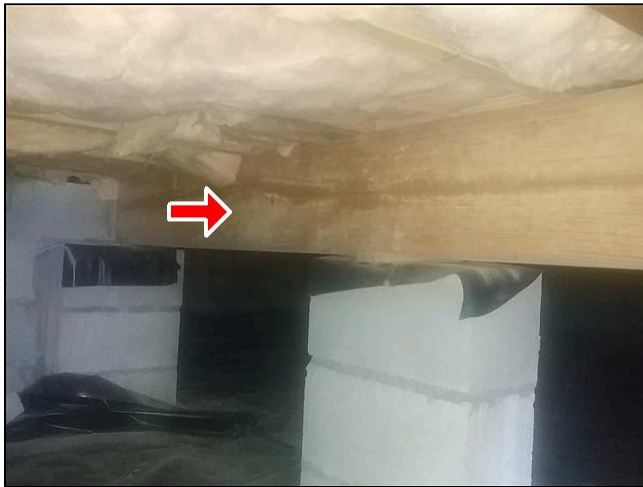
(2) **Safety issue** - Signs of fungi growth are present on some of the floor joists. I did not inspect, test or determine if this growth is a health hazard. The underlying cause is moisture. I recommend contacting a mold inspector or expert for investigation.

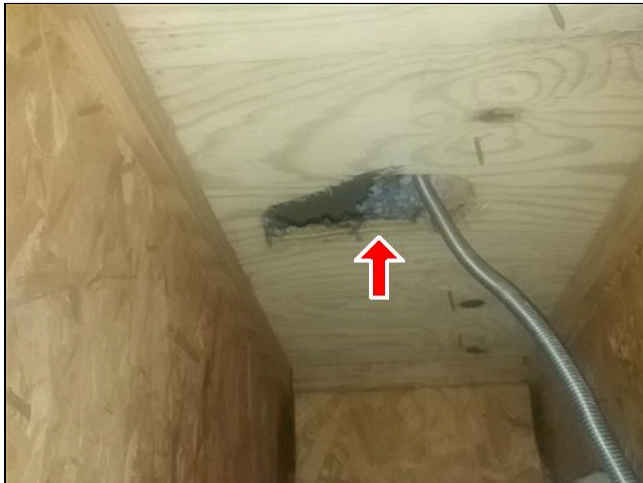
5.3 Item 5(Picture) Crawlspace

(3) The opening in the sub-flooring where the gas supply enters should be sealed, helping to keep out unwanted pests. A contractor should evaluate and make the necessary repairs.

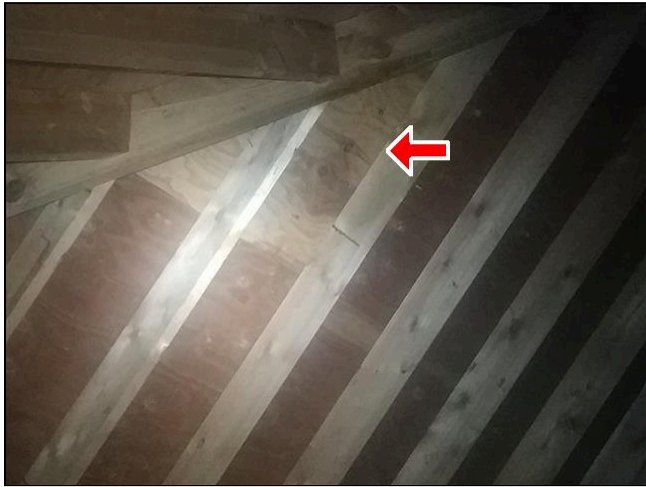
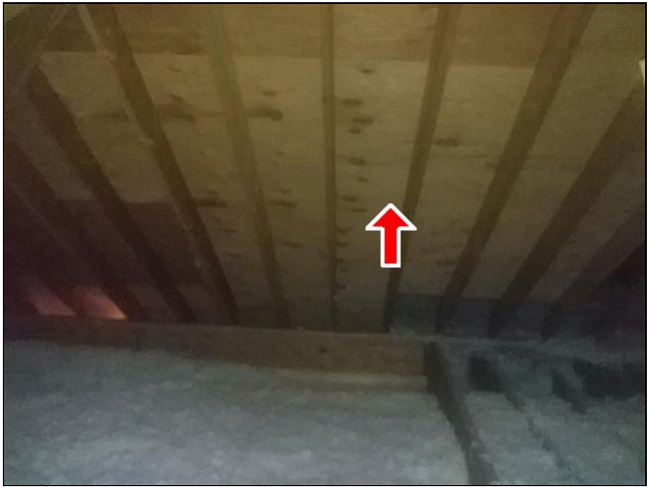
FYI - It appears that sections of the roof decking have been replaced.

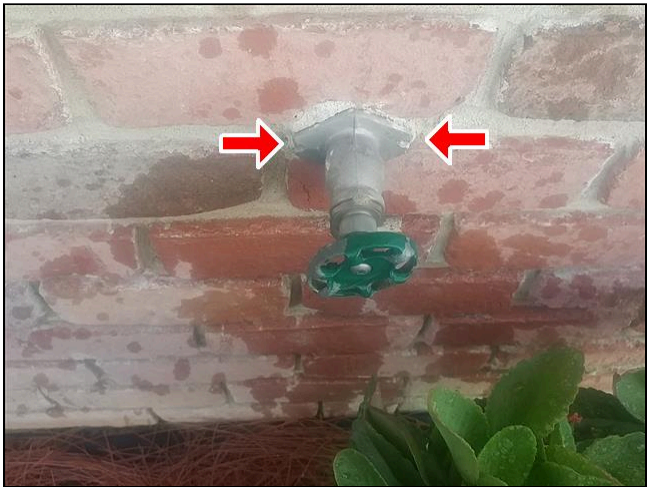
When in the "on" position, water leaks from around the handle on the exterior faucets, located on the rear and left side of home (facing front). In addition, the faucets are not secured to the home. A plumber should evaluate and make the necessary repairs.

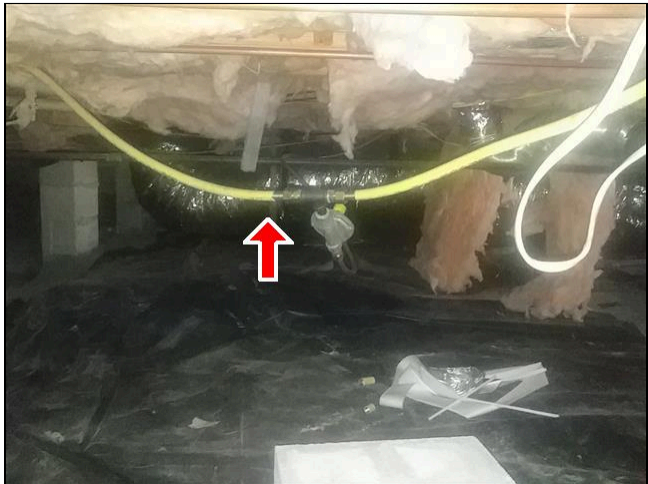
6.4 Item 1(Picture) Crawlspace

Safety issue - The gas supply line, located in the crawlspace, is not properly supported. A contractor should evaluate and make the necessary repairs, protecting the lines from damage.

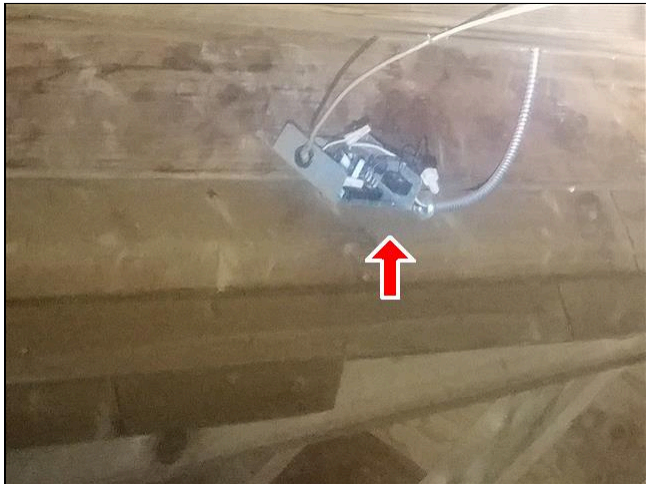
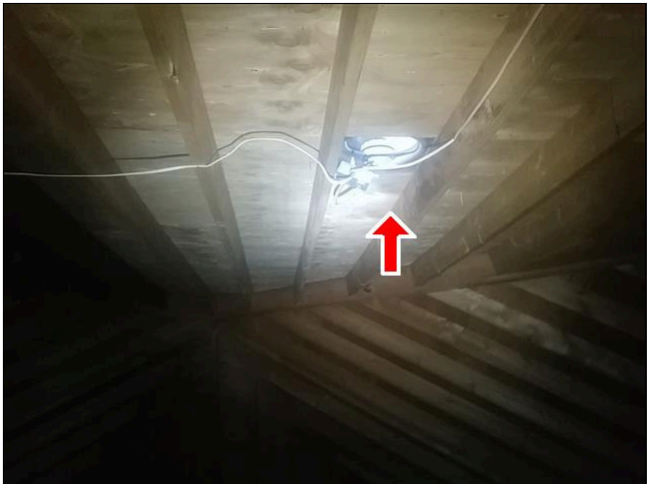
(1) **Safety issue** - The electrical connections for the attic fans should be concealed in a junction box. An electrician should evaluate and make the necessary repairs, reducing the risk of a fire and electrical shock.

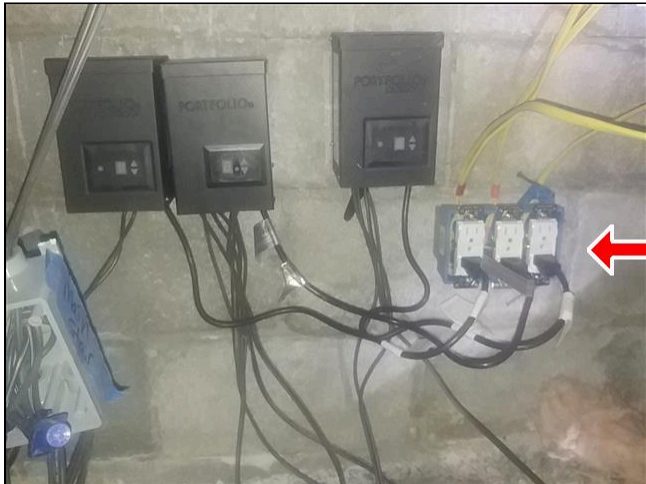
7.2 Item 3(Picture) Crawlspace

(2) **Safety issue** - Face-plates should be installed for the receptacles, located in the crawlspace, reducing the risk of electrical shock. An electrician should evaluate and make the necessary repairs.

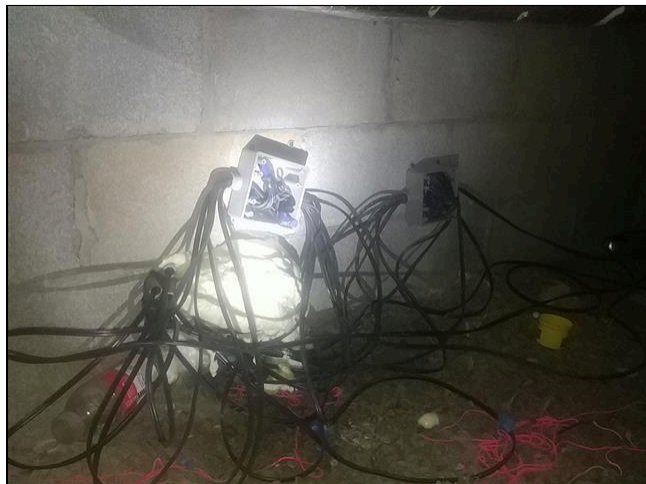
7.2 Item 4(Picture) Crawlspace

(3) The wiring, presumably for the low voltage landscape lighting, is not properly routed and secured. An electrician should evaluate and make the necessary repairs.

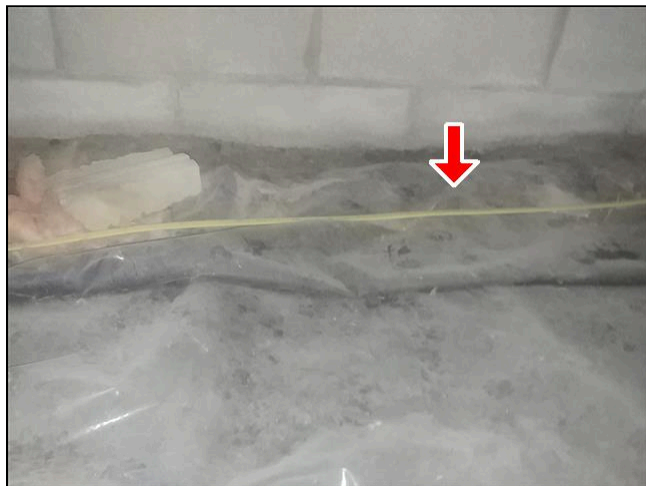
7.2 Item 5(Picture) Crawlspace

(4) **Safety issue** - Several of the crawlspace branch circuits are laying on the ground and are not properly supported. An electrician should evaluate and make the necessary repairs, reducing the risk of electrical shock.

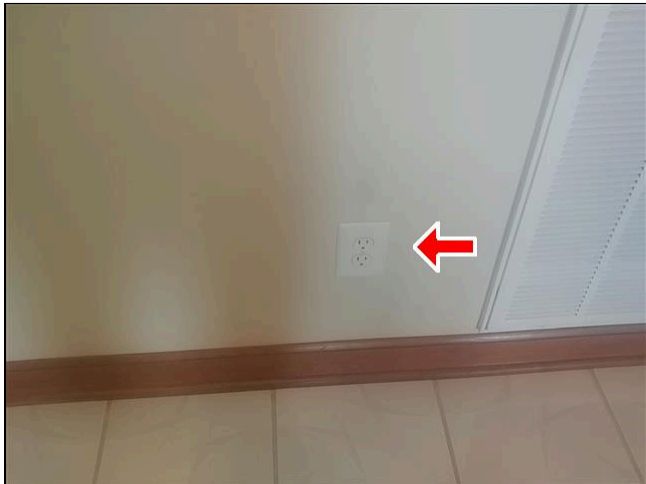
7.3 Item 1(Picture) Dining room

Safety issue - An electrician should secure the loose electrical receptacles in the dining room and master bedroom, reducing the risk of electrical shock.

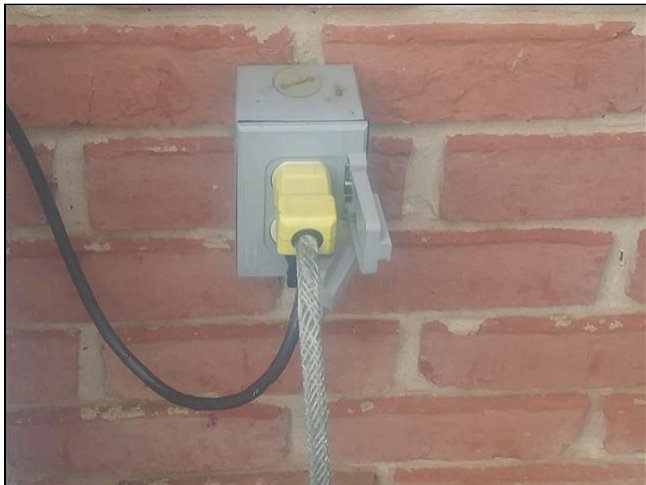
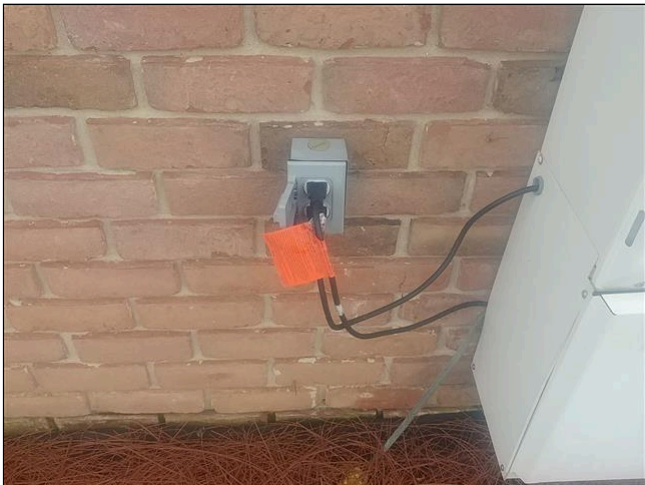
(1) **Safety issue** - The electrical receptacles that service the water heaters on both sides of the home are not Ground Fault Circuit Interrupter (GFCI) protected. GFCI protection is required within on the exterior of home. An electrician should evaluate and make the necessary repairs, reducing the risk of electrical shock.

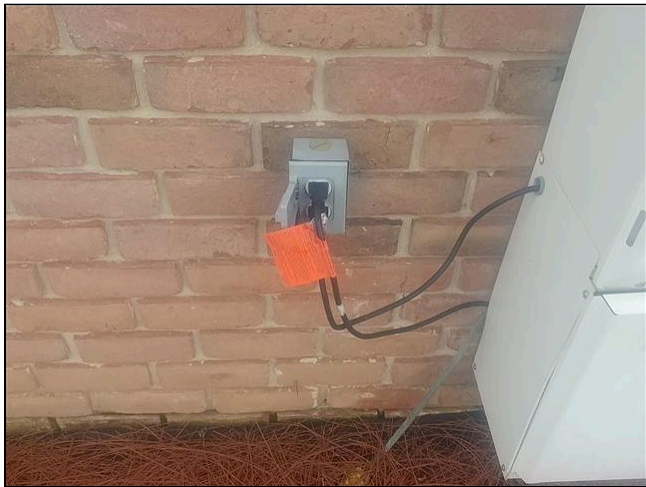
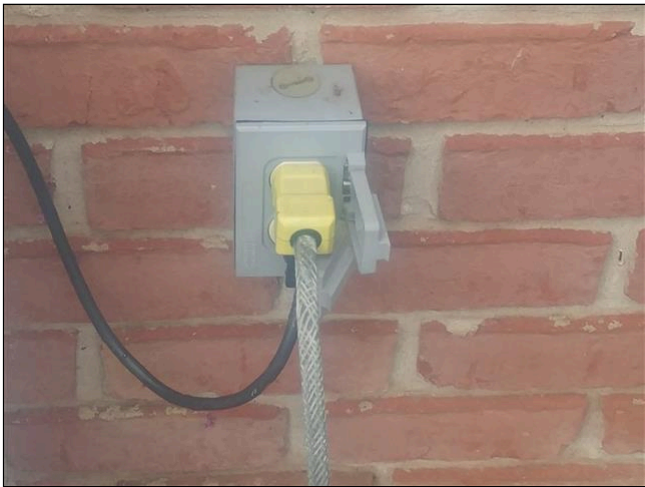
(2) **Safety issue** - Weatherproof covers designed for outdoor use should be installed on the electrical receptacles, located on left and right side of home. An electrician should evaluate and make the necessary repairs, reducing the risk of electrical shock.

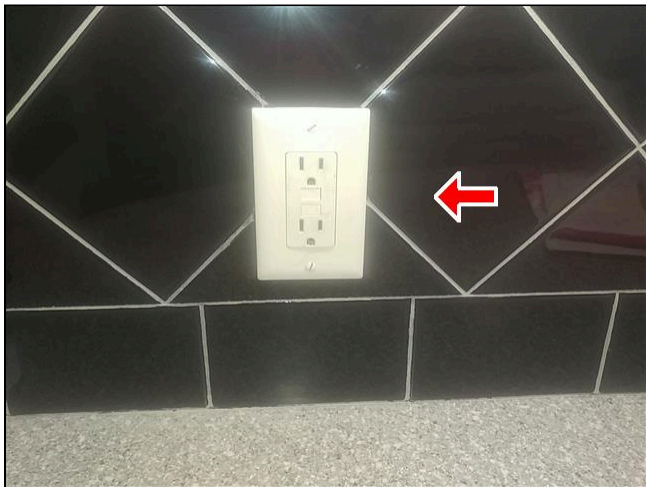
7.5 Item 1(Picture) Kitchen

Safety issue - The GFCI receptacles, located on the left side of the kitchen sink, will not trip when tested. An electrician should evaluate and make the necessary repairs, reducing the risk of electrical shock.

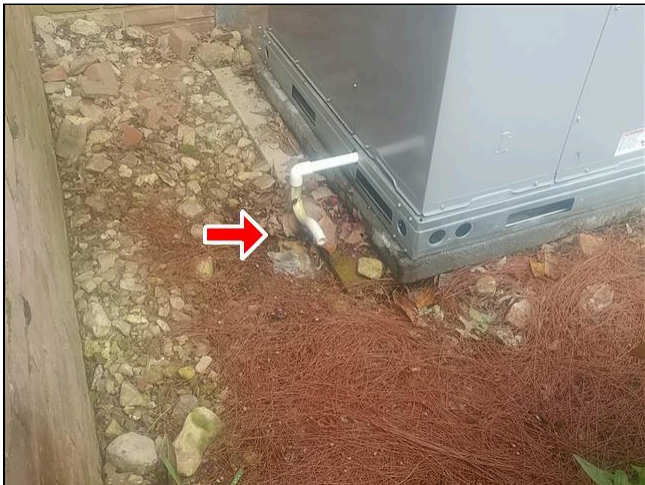
8.3 Item 1(Picture) Left side (facing front)

(1) The Heating, Ventilation & Air Conditioning (HVAC) condensation drain lines, located on the HVAC units (right & left side of home - facing front), should be extended to allow water to drain away from the units and concrete pads, which supports the units; else water can cause damage to the units and concrete pads.

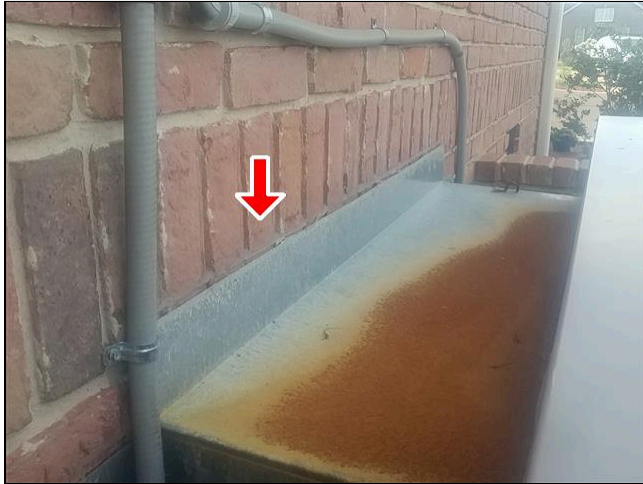
8.3 Item 3(Picture) Left side (facing front)

cause damage to the ducts. In addition, the metal housing is rusty and should be replaced or repaired, helping to protect the ductwork.

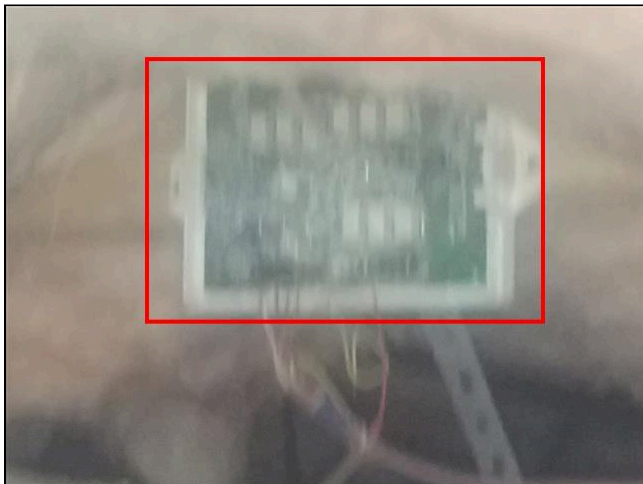
8.3 Item 4(Picture) Crawlspace

(3) The cover is missing from one of the HVAC control panels, located in the crawlspace. The cover protects the panel from damage. An HVAC technician should make the necessary repairs.

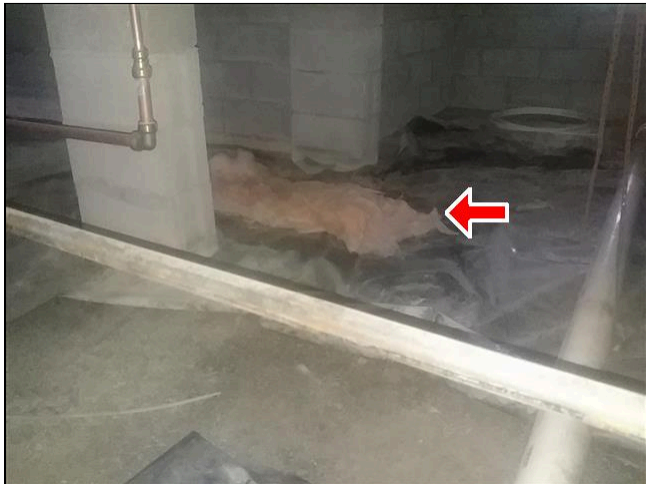
9.1 Item 1(Picture) Crawlspace

Sections of the insulation under the floor are loose and falling, possibly due to the high moisture content, noted earlier. Replacing or securing the loose insulation should make the home more energy efficient.

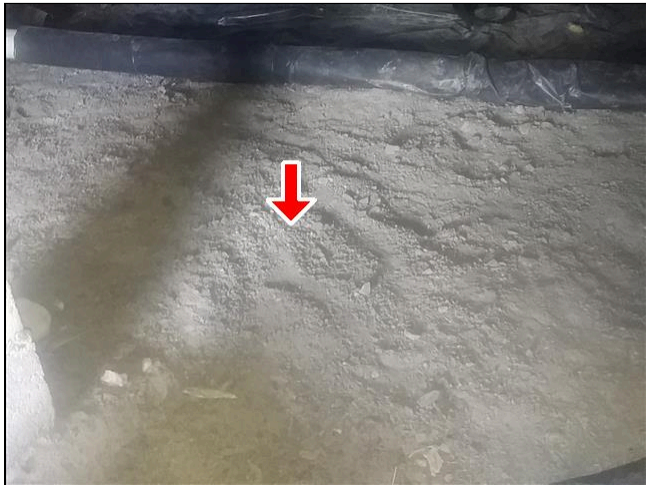
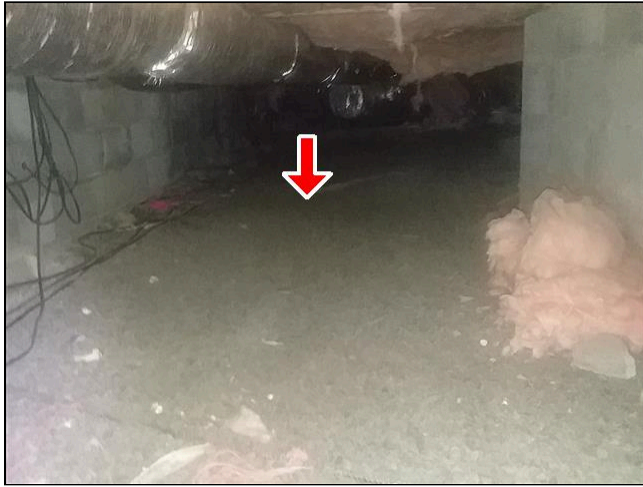
The vapor barrier on the crawlspace floor is not covering all areas. A vapor barrier provides added protection to the floor system from moisture or dampness that can enter from the ground. The vapor barrier should cover all of the crawlspace floor / ground.

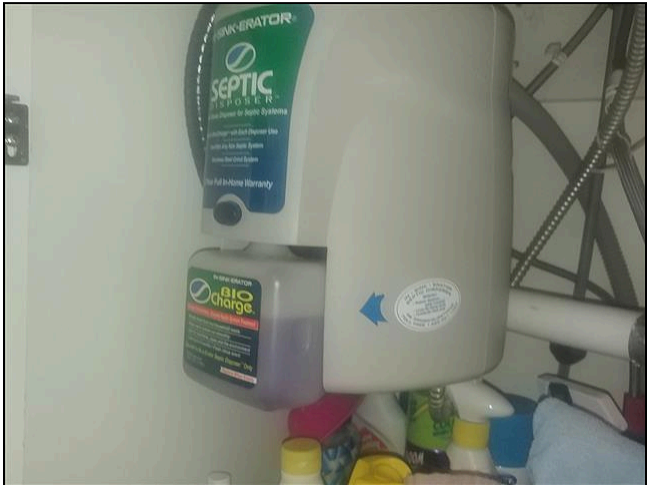
10.4 Item 1(Picture) Kitchen

The food waste disposal is inoperable. A contractor should evaluate and make the necessary repairs.

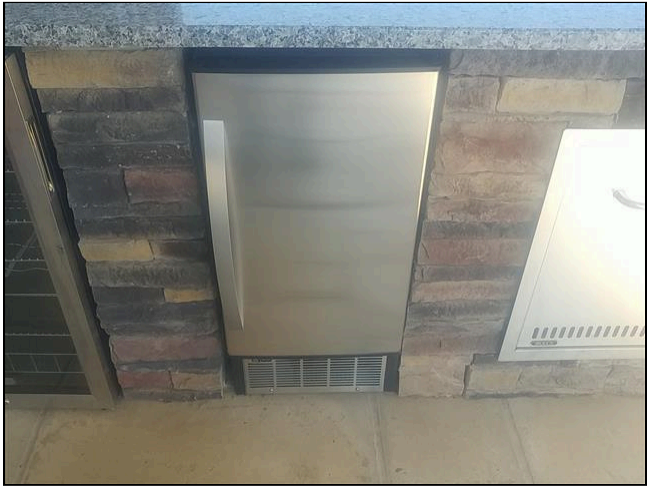
12.0 Item 1(Picture) Outdoor kitchen

The ice maker was not in operation, possibly not connected to a power or water source.

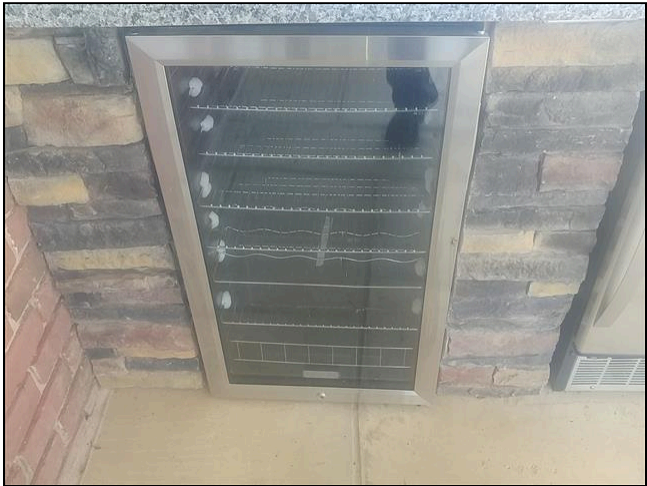
12.1 Item 1(Picture) Outdoor kitchen

The wine cooler was not in operation, possibly not connected to a power source.
