Inspection Report

Property Address:
123 Sample Street
TN

Chastain Home Inspection, LLC

Date: 8/3/2018	Time: 08:00 AM	Report ID: Chgastain2023
Property: 123 Sample Street TN	Customer:	Real Estate Professional:

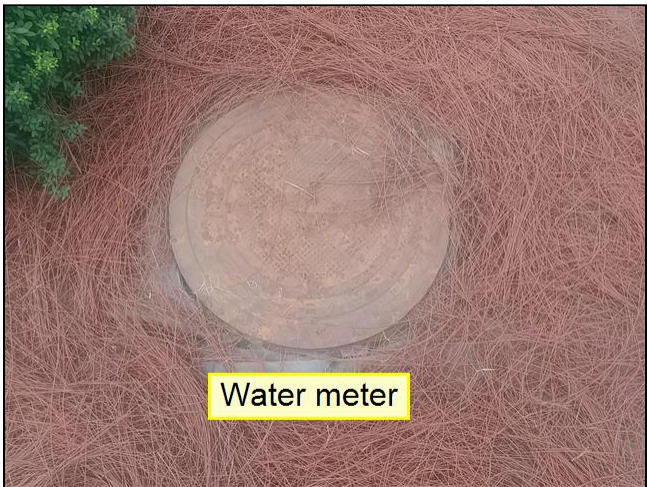
6.3 Item 1(Picture) Front

The main water shut-off is located at the water meter (front of home).

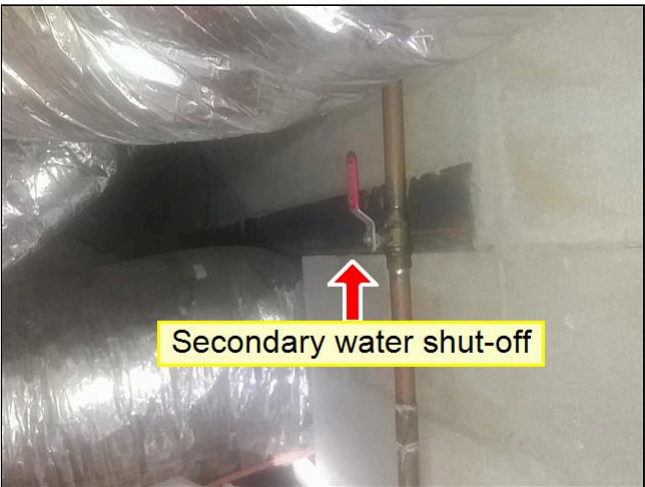
6.3 Item 2(Picture) Crawlspace

The secondary water shut-off is in the crawlspace.

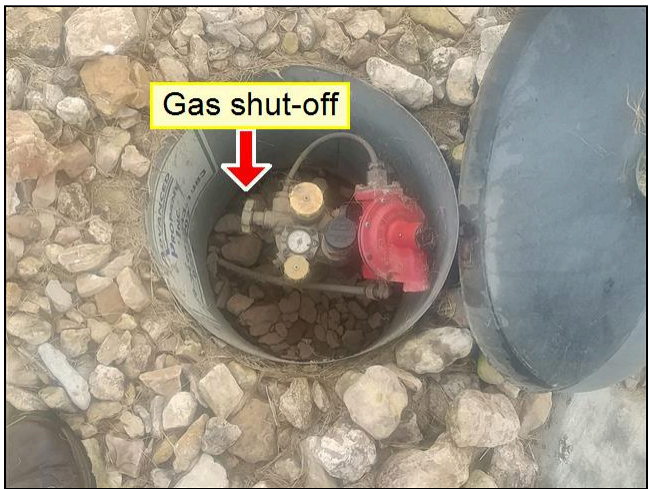
6.5 Item 1(Picture) Front

The main fuel shut-off is located at the propane tank (front of home).

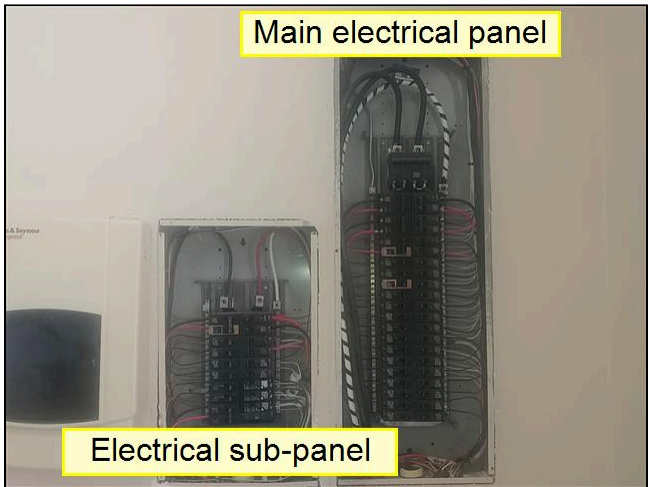
7.6 Item 1(Picture) Laundry room

The main electrical panel is located in the laundry room.

The electrical sub-panel is located in the laundry room.

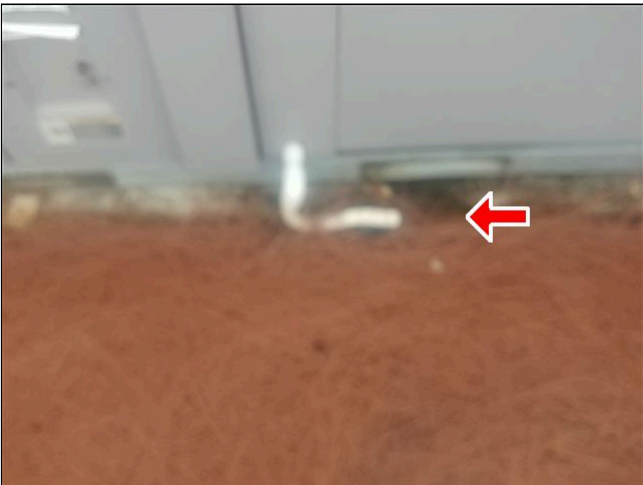
8.3 Item 2(Picture) Right side (facing front)

(2) Sealant should be applied in the area where the HVAC metal housing adjoins the home, else water can

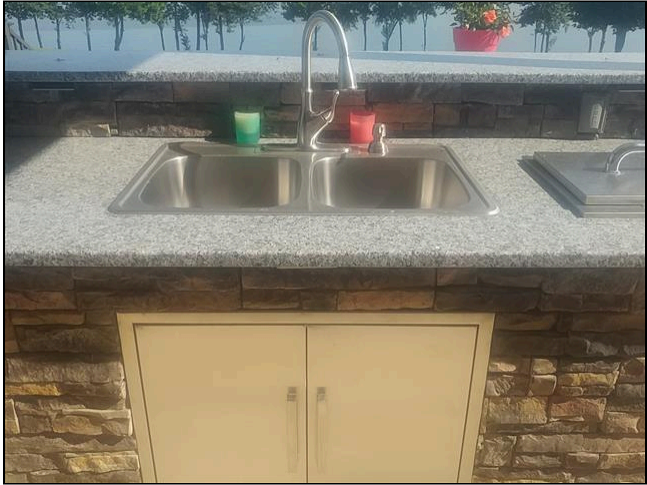
12.3 Item 1(Picture) Outdoor kitchen

The sink was not connected to a water source. Therefore, I was not able to inspect the sink.
